# **Coral Cay Conservation Sub-Aqua Club**

## **Isles of Scilly Expedition 1993**

### **Preliminary Report**

#### **4.3. *Assessment of Wine Cove refuse disposal site***

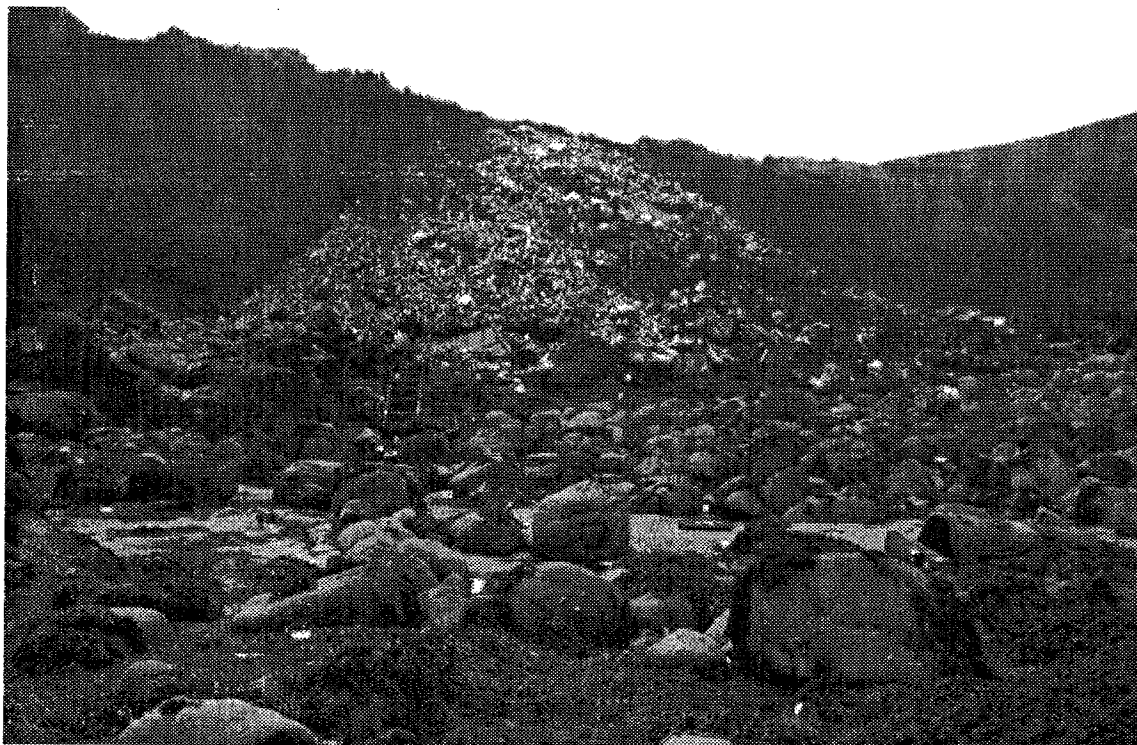
Plate One: The Disposal Area Wine Bay St Martins

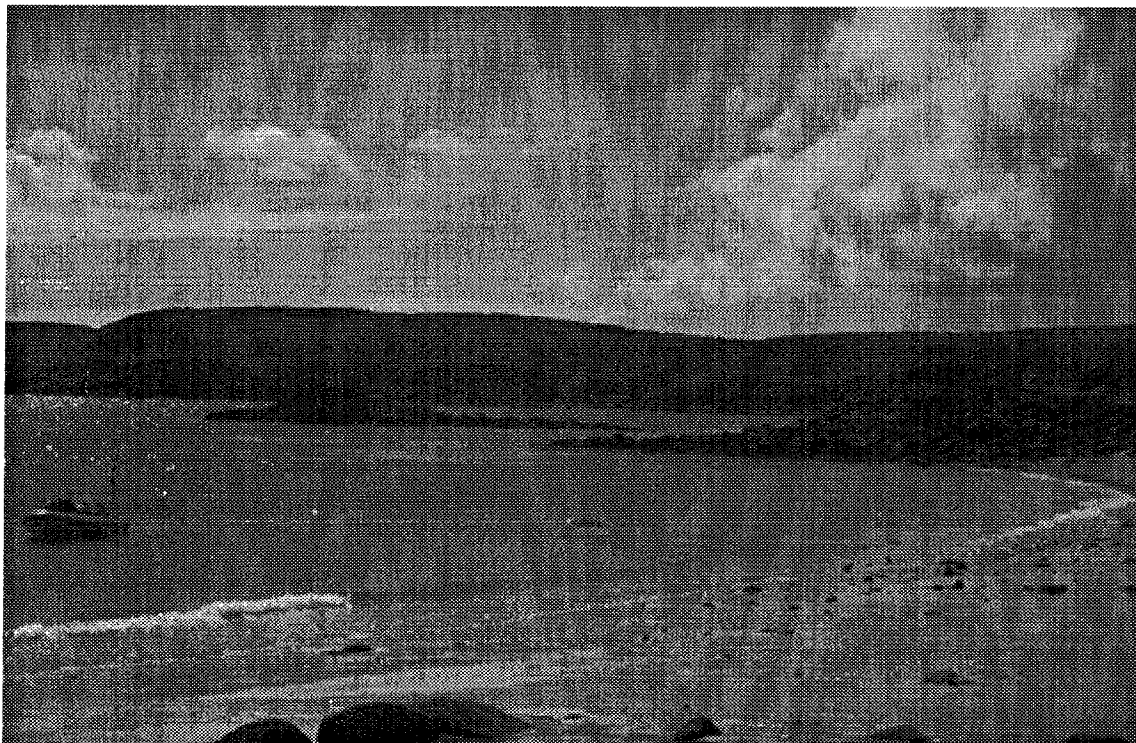
Plate Two: Great Bay with the Wine Cove Disposal Site in the middle distance.

The disposal site is visible from the beach at Great Bay (Plate Two) and may be observed by walkers following the cliff top path around St Martins. It therefore has significant impact on the landscape and also represents a hazard to public health in its present state.

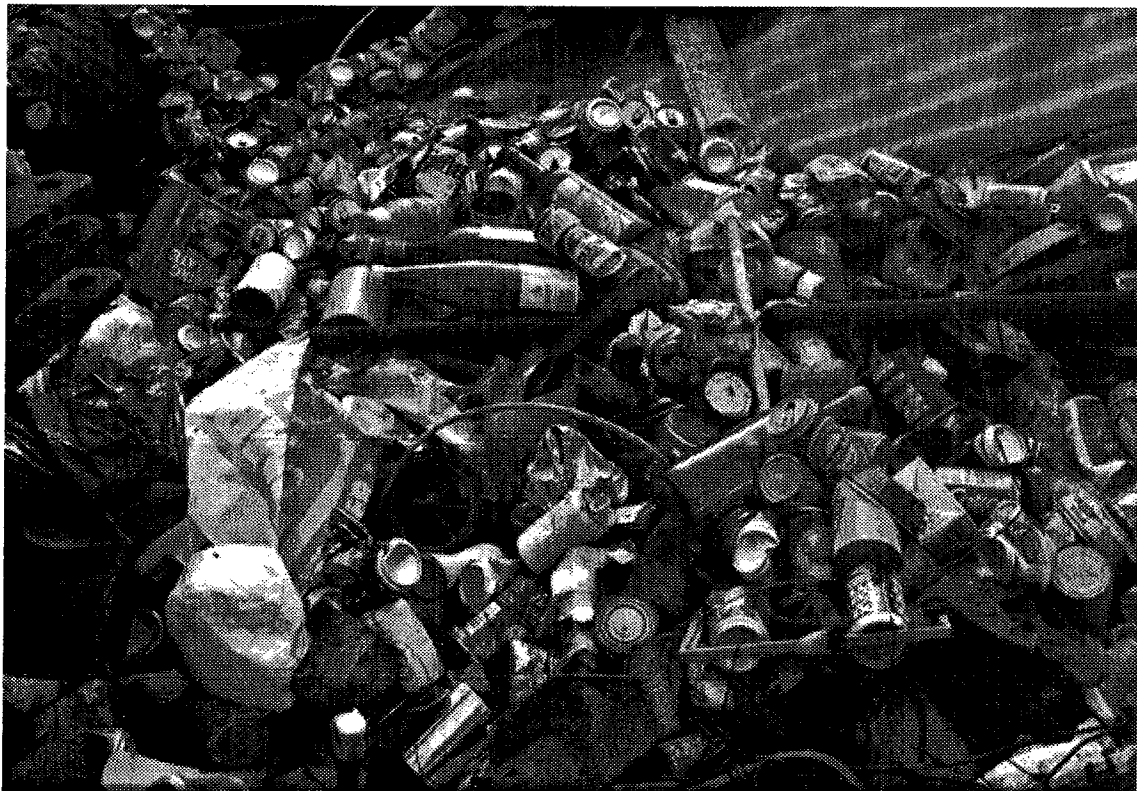
No quantitative study of the refuse was carried out, however, the area of deposition was studied qualitatively. The majority of the freshly deposited refuse consisted of drinks cans and bottles (Plate Three). Little or no organic material was noticed amongst the refuse and most of the larger metal items were badly corroded and appeared to have been present for some time although a few domestic appliances were less badly corroded and may have been deposited more recently.

Plate Three: Close-up of refuse site.

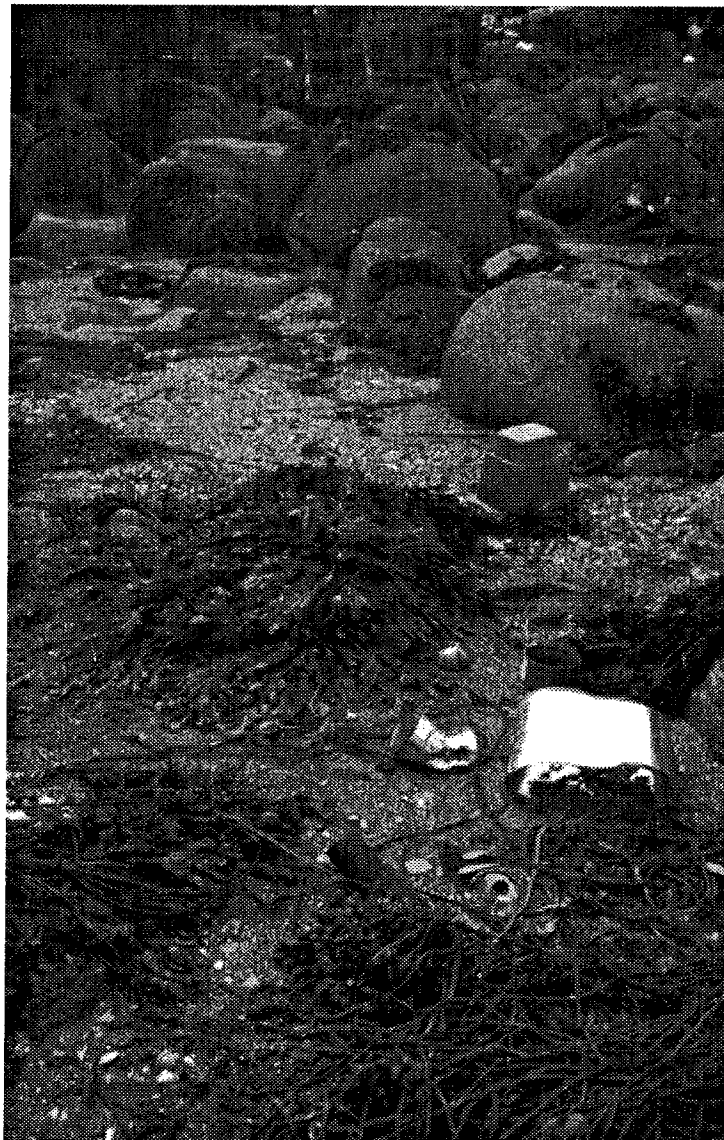
Plate Four: Coarse sand further down the beach at Wine Cove, note brown discolouration.

The absence of decreased metal concentrations away from the tip face and the noted iron coatings on the sand grains suggests that re-disposition from solution may largely account for this contamination. This process is most likely to occur within the interstitial environmental of the beach sands, with occasional episodes of disruption and physical dispersion of the coated sands by wave action. The percolation of leachate waters is liable to play a major role in this contamination process.

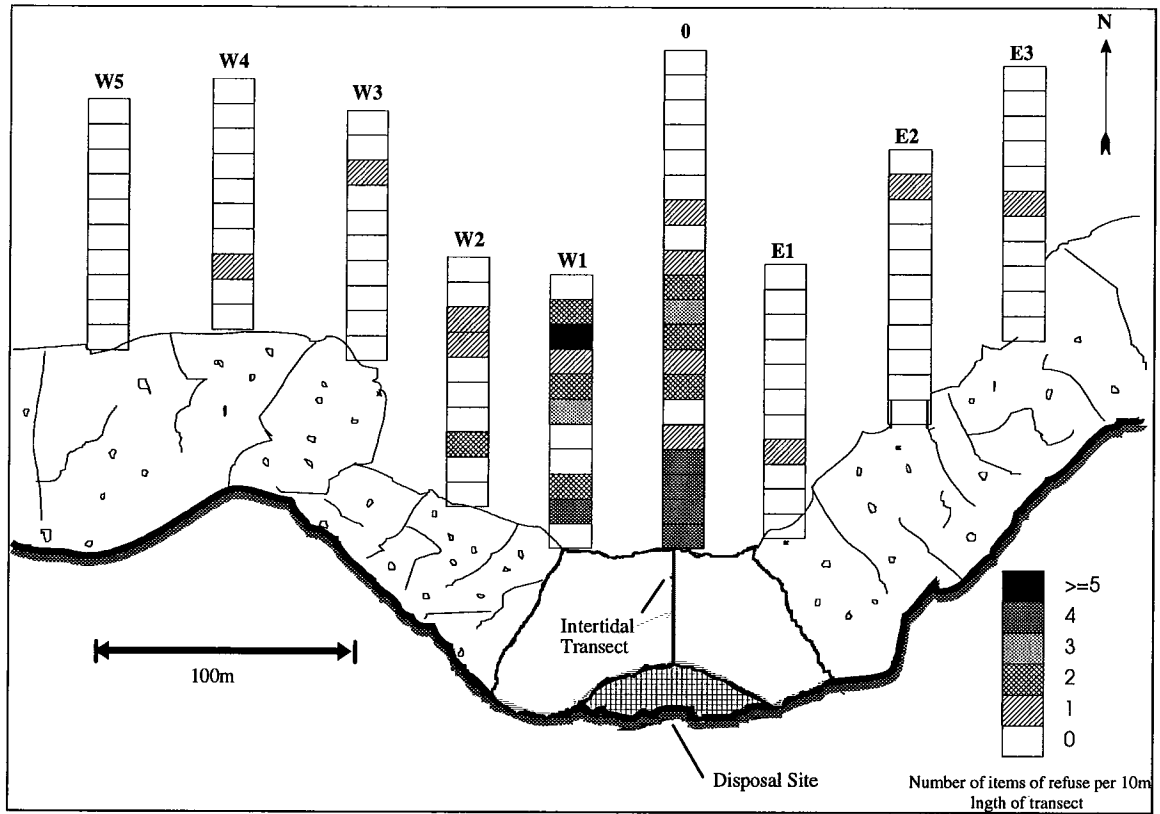
Figure Two: Distribution of refuse in sublittoral area of Wine Cove Disposal site

The results from the transect swims are summarised in Appendix One and Figure One. The majority of the debris observed occurred along the 0 and W<sub>1</sub> transect. Heavier objects were concentrated along the 0 transect within 50m of low water. Most of the material distributed further away consisted of drinks can fragments. These were observed up to 100m offshore on the W<sub>1</sub> transect.

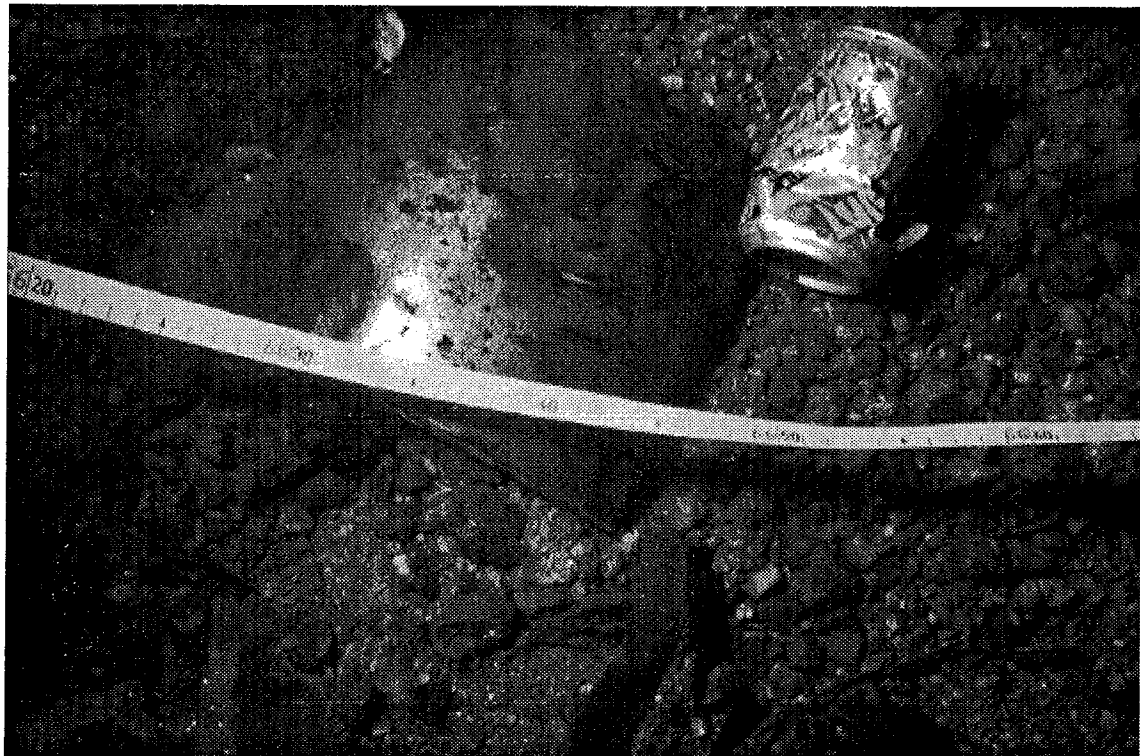
Plate Five: Refuse in a sublittoral area off the disposal site, note contamination of the sediment.
